## EPIL TEST REPORT

**Project No.:** H13-60004-1

**Equipment under Test:** MV Capacitor

**Tested According to:** IEC 60871-1:2014

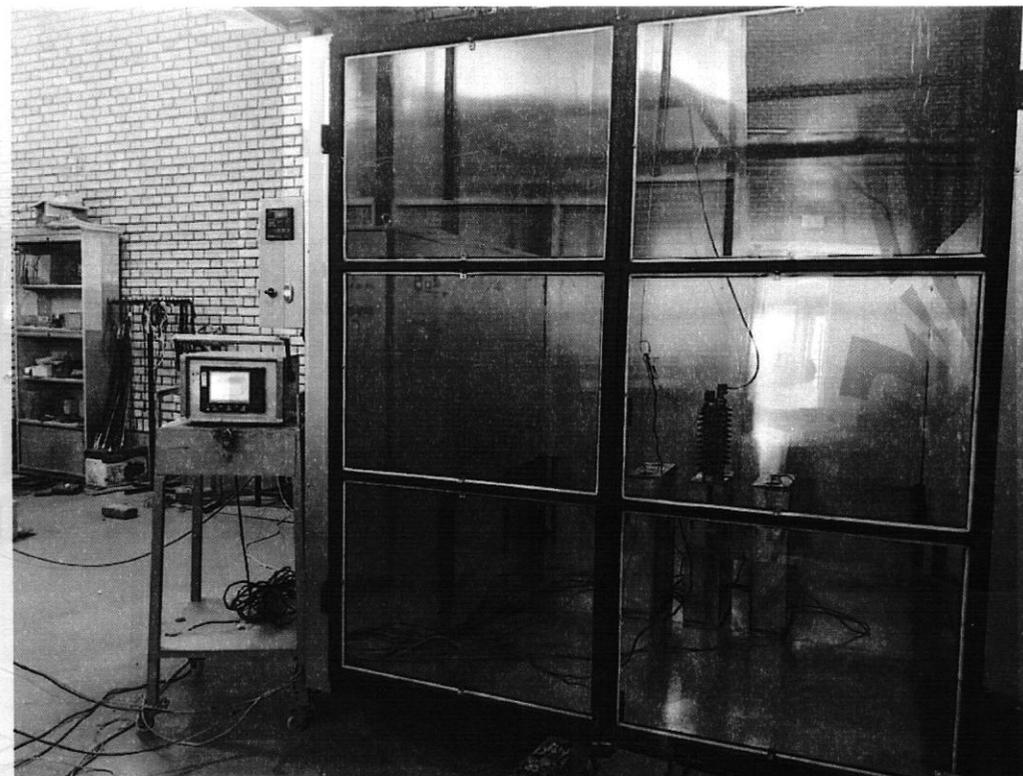
The capacitor unit subjected to the test is placed between two dummy capacitors each containing resistors. The dissipation in the resistors is adjusted to a value such that the case temperature of the dummy capacitors near the top opposing faces are equal to or greater than those of the test capacitor. The separation between the units is 10 cm, which according to manufacturer claim, is equal to or less than the normal spacing. The assembly is placed in a heated enclosure with no forced ventilation with ambient air temperature at or above the appropriate temperature shown in Table 2 of IEC 60871-1 (55 °C for symbol D capacitor). The test capacitor is subjected for a period of at least 48 h, to an a.c. voltage of substantially sinusoidal form. The magnitude of the voltage throughout the test is adjusted to 13.96 kV to give an output of 1.44 times the capacitor rated power.

**Figure 3: Equipment under thermal stability test**
