EPIL/HV TEST REPORT

Project No.: *H13-60003-1*
Equipment under Test: *MV Capacitor*

Type	*: PK 200/19.05 EDRI*
Serial Number	*: T-T-19.05*
Rated Voltage	*: 19.05 kV*
Rated Power	*: 200 kVAR*
Rated Capacitance	*: 1.76 μF*
Rated Frequency	*: 50 Hz*
Rated Current	*: 10.5 A*
Insulation Level	*: 50/145 kV*
Temperature Category	*: -40/55°C*

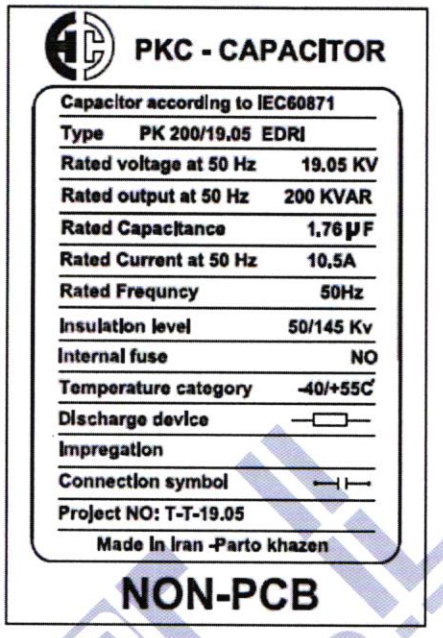
Figure 1: Nameplate of equipment under test

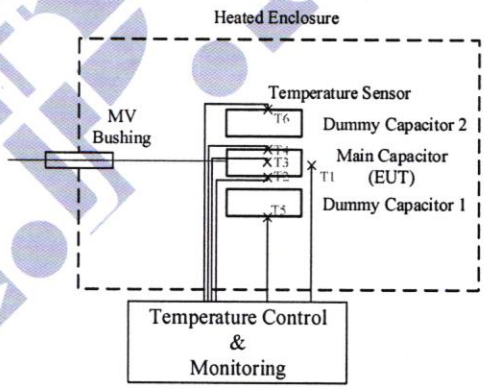
Figure 2 (refer to section 3: FIGURES of the test report) shows the sensors arrangement during the thermal stability test. The sensors are applied as follows:

T1: Test room temperature
T2: Main capacitor near top temperature # 1
T3: Main capacitor top temperature
T4: Main capacitor near top temperature # 2
T5: Dummy capacitor 1 near top temperature # 1
T6: Dummy capacitor 1 near top temperature # 2
T7: Dummy capacitor 2 near top temperature # 1

Figure 2: Sensors arrangement during the thermal stability test

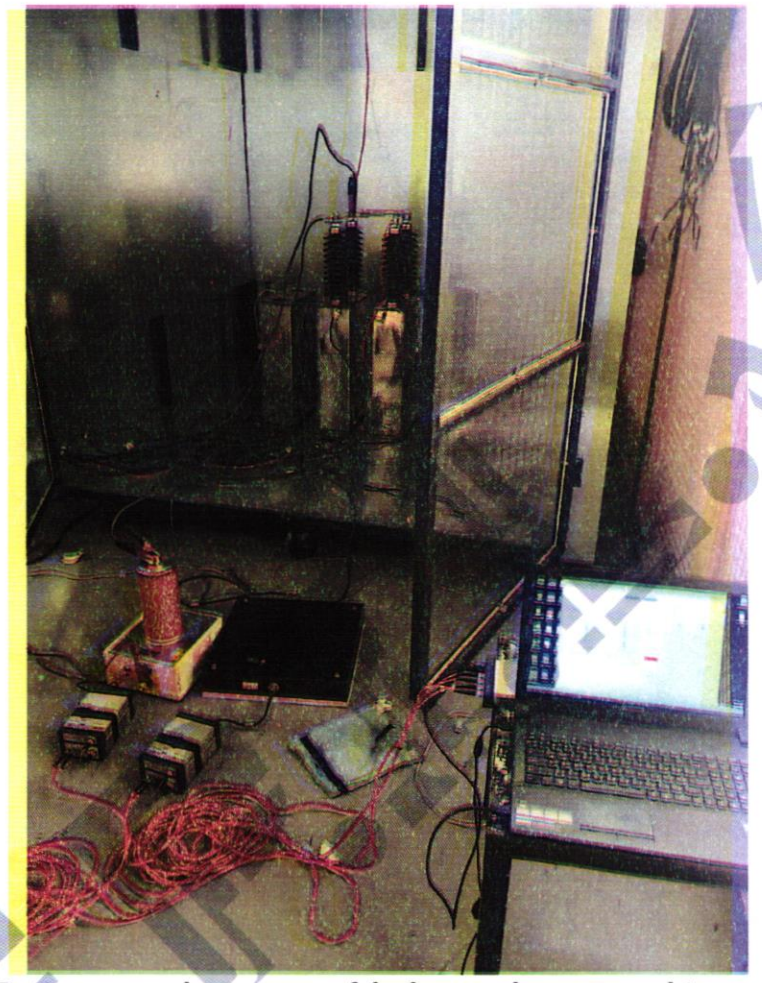
Figure 3: Equipment under tangent of the loss angle test at ambient temperature
